# Modification of river constructions

## Iwubetsu River

# Rusha River

# Sashirui River

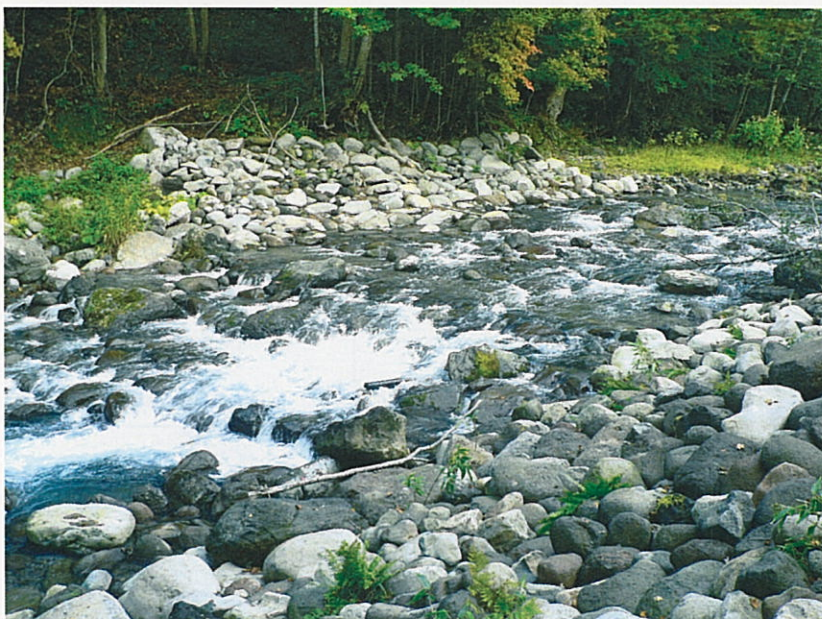
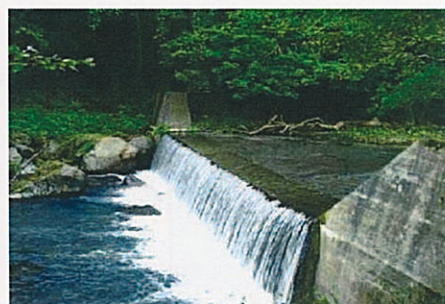
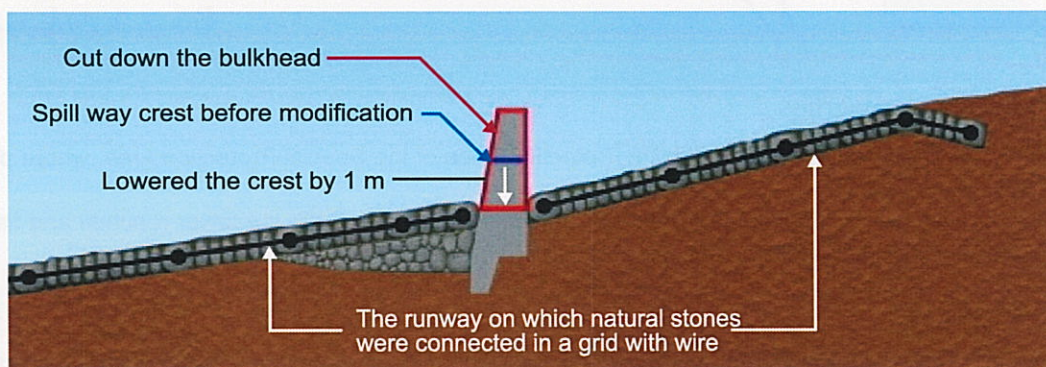
With regard to the check dam on the tributary Akai River (administrative agency: Hokkaido Regional Forest Office), the Working Group's assessment concluded that the influence of the modification on human properties (residences, roads, bridges, etc.) would be minor partly because the river is relatively stable.

The check dam shown below was modified in fiscal year 2006.

The runway was made experimentally using natural stones to meet the following three conditions: upstream migration is not impeded, the view worthy of world natural heritage status is restored and original erosion control functions are retained.

The dam was cut down by 1 m, and the upstream and downstream sides of the dam were sloped with natural stones. Using a traditional stone assembling technique, the stones were fixed with wire in an irregular arrangement to create a natural appearance.

A field test using pink salmon confirmed passage over the modified dam.

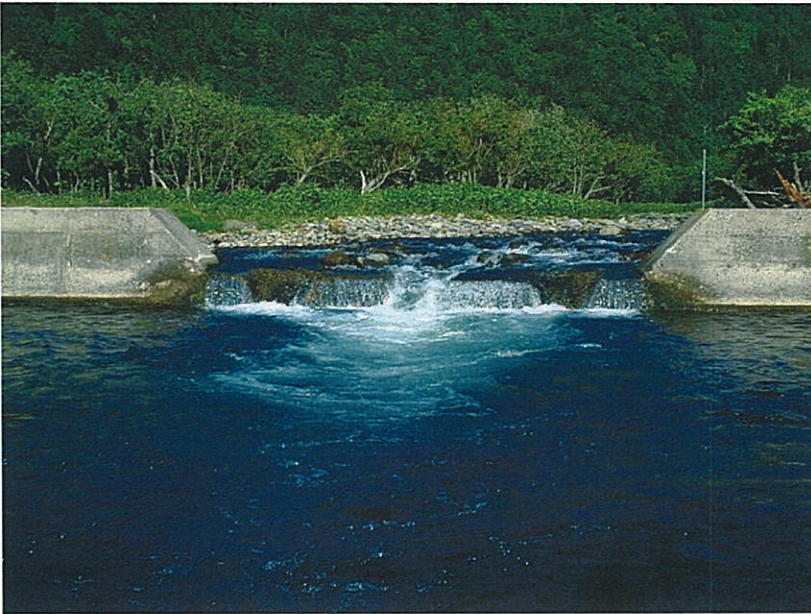
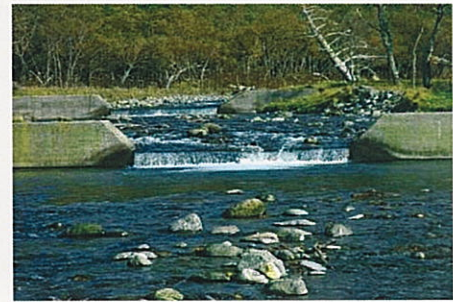
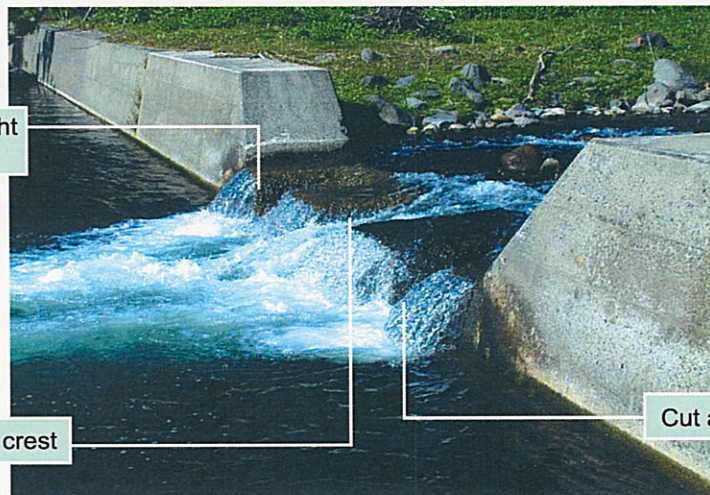
Migrating chum salmon had been observed in the upstream of the check dams (administrative agency: Hokkaido Government) in the Rusha River. However, the previous flow conditions and elevation drop made passage difficult from November through winter when water temperature is low. The Working Group concluded that these two dams should be modified to facilitate salmonid passage. The check dam shown below was modified in fiscal year 2006.

Cut a notch on the right side of the crest

Cut down the central crest

Cut a notch on the left side

To remove the obstacles posed by currents and the drop, the center of the crest was cut down to create a rectangular opening, a 'slit', and a 'notch' was carved on both right and left sides of the downstream edge of the lowered crest. Field survey after modification found that the number of chum salmon redds increased.

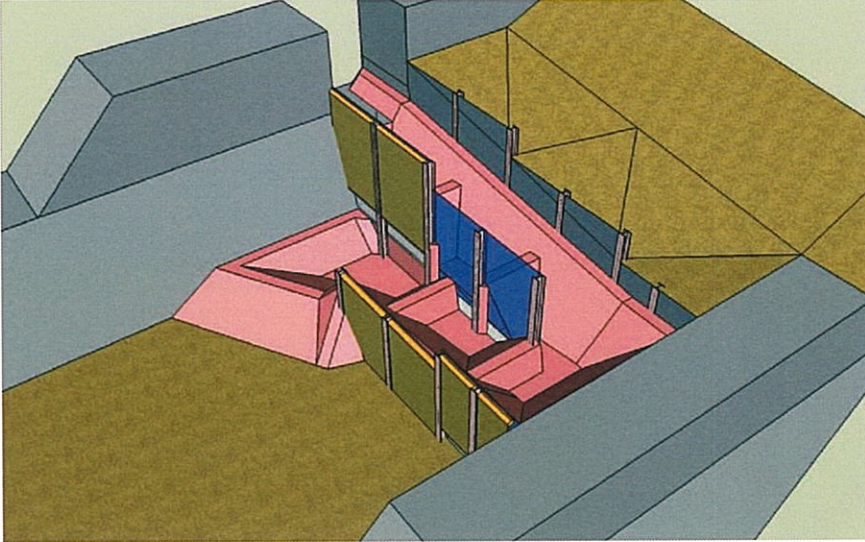
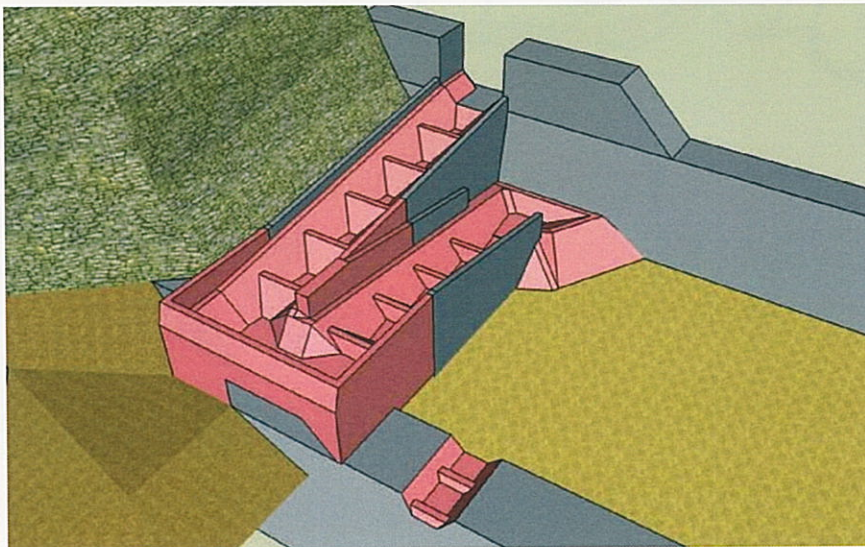
With regard to two check dams in the Sashirui River (administrative agency: Hokkaido Government), the Working Group concluded that modifying the existing fishway systems (pool style) would likely improve salmon migration. The check dam shown below was modified in fiscal year 2007.

The construction and maintenance costs were minimized, while its design allowed fish migration, the retention of the original functions as a check dam and the conservation of the mountain stream environment. The sidewalls of the pools were changed to trapezoids in order to prevent flow conditions from disturbing fish passage, ensure adequate pool depth and discharge sediment efficiently from the fishway.
