# Modification of river constructions

## Iwubetsu River

# Rusha River

# Sashirui River

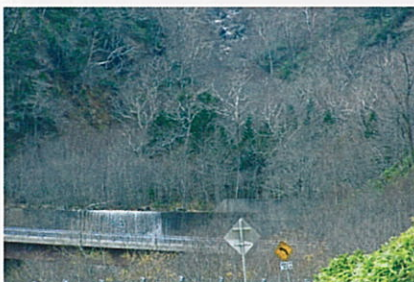
An upper reach in the Rausu River

River constructions were decided not to be modified if they met one of the following conditions: the river construction has been installed in a river with a high frequency of mountain-slope disaster (left photograph); it is located in the upstream of piled boulders impeding salmon migration (center); and it currently allows salmon migration (right).
